PRELIMINARY INVESTIGATION OF THE FAILURE OF  
PRESSURIZED STIFFENED CYLINDERS

By Norris F. Dow and Roger W. Peters

Langley Aeronautical Laboratory  
Langley Field, Va.

May 20, 1955

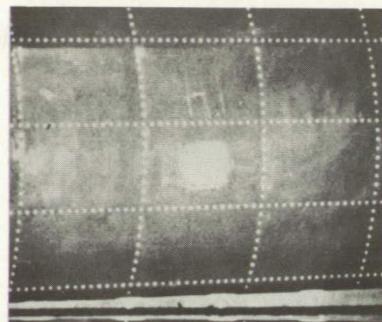
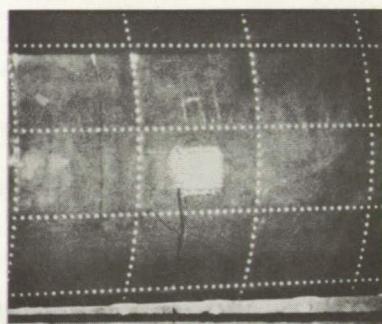
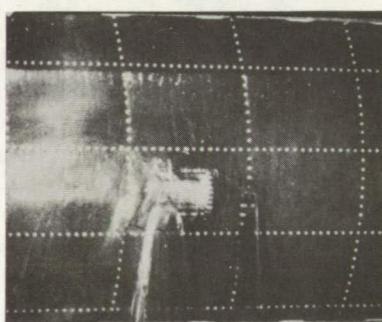
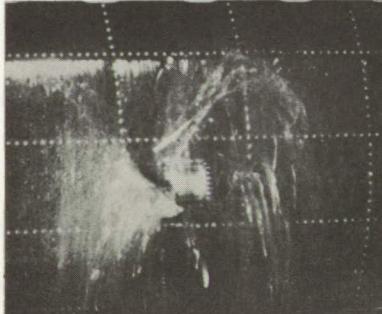
The results are presented in the last three columns of table 1. Two distinct modes of failure occur: one is characterized by a gradual crack growth (see fig. 3); the other can only be described as an explosive failure in which the crack opens suddenly over more than one bay.

Figure 3.- Failure by gradual crack growth of cylinder 2.

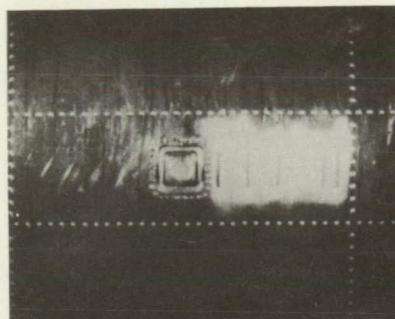
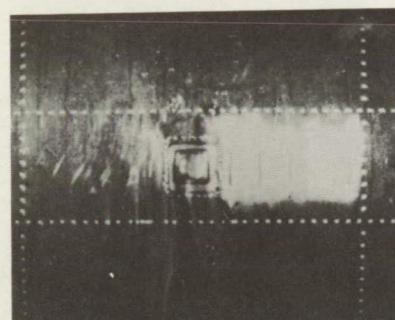
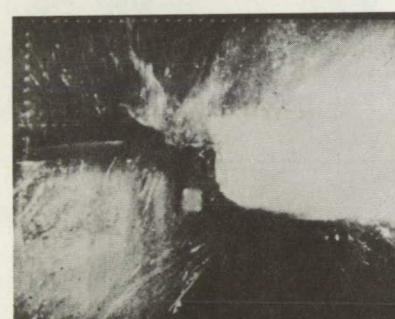
width, failing the internal ring at one of its 20 notches (see fig. 4), or tearing the skin away from the ring.

The hoop stress level is not the sole cause of the difference between the modes of failure. In fact, specimen 4 had a gradual crack growth at a higher stress level (30 ksi) than that for specimen 3 (20 ksi) which had an explosive failure.

Figure 4.- Explosive failure of cylinder 3.

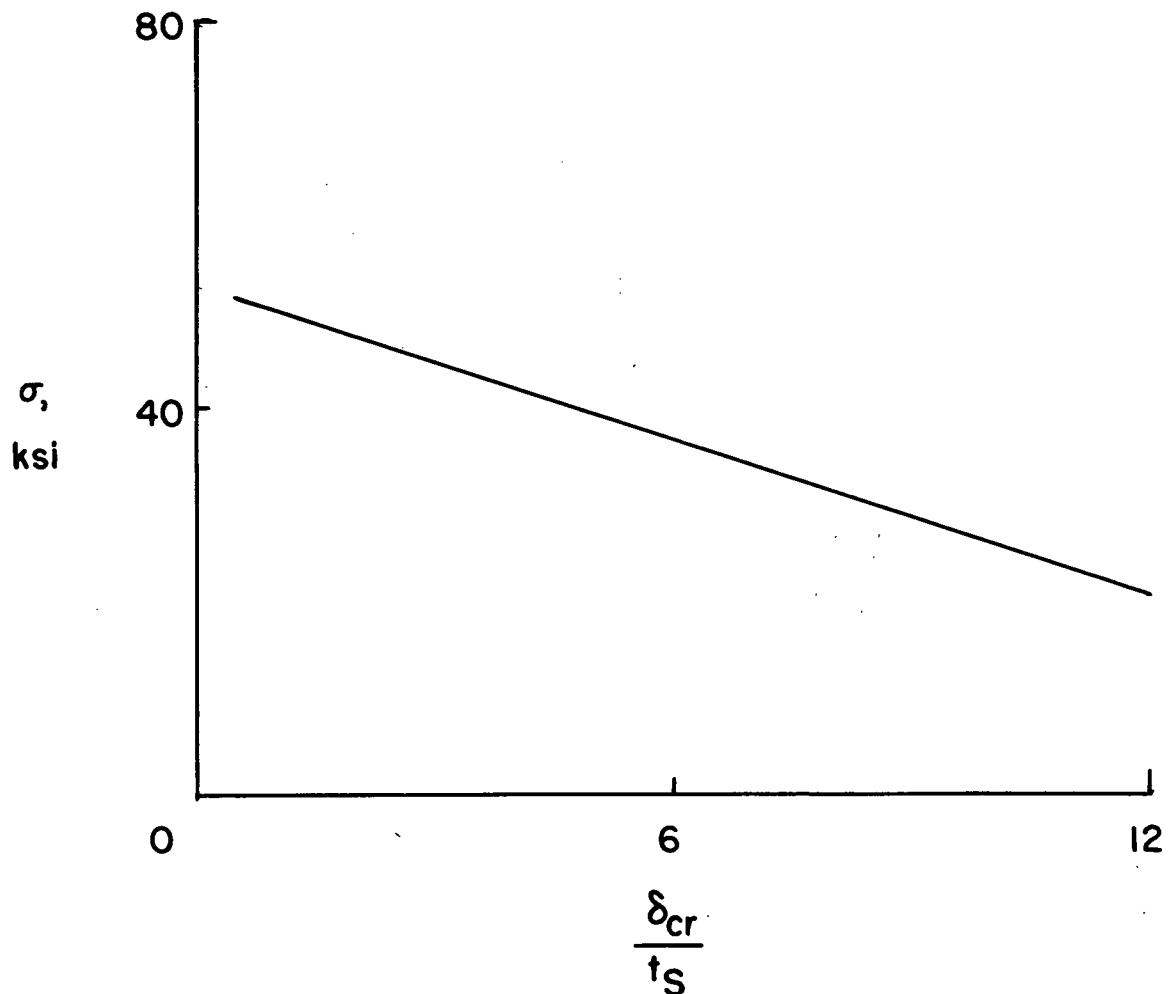
Because the radius-to-thickness ratio  $r/t_S$  is generally large for fuselage construction, the failure of pressure cylinders representative of fuselage construction can perhaps be considered similar to that of cylinders of infinite  $r/t_S$ . Accordingly for unstiffened cylinders, a curve should exist, similar in character to that for flat sheet of figure 8 of reference 3, relating the hoop tensile stress  $\sigma_{hoop}$  to cause explosive-type failure to a critical crack length  $\delta_{cr}$ . A portion of such a curve derived from figure 6 of reference 4 is presented in figure 5.

Figure 5.- Relationship between tensile stress and critical crack length for 2024-T3 (formerly 24S-T3) flat sheet of width-thickness ratio of 20 (from ref. 4).

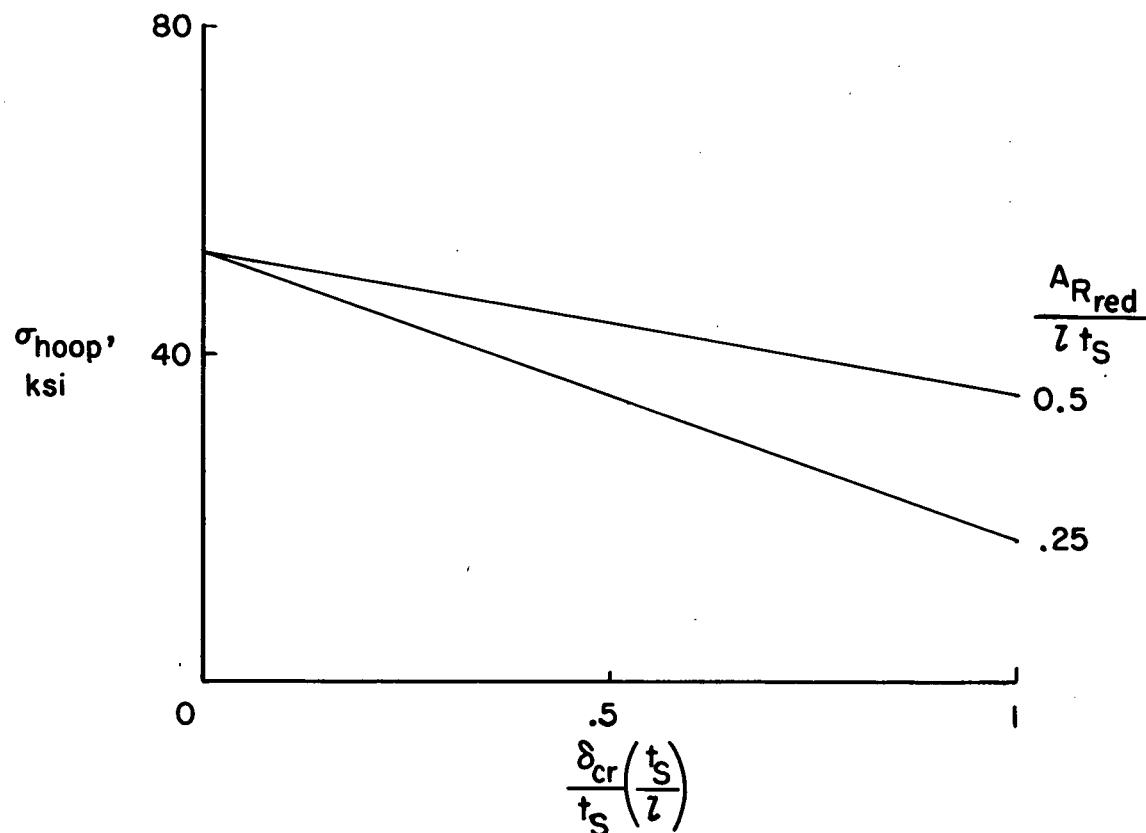
If a linear variation with stress from  $\delta_{cr}/t_s = 0$  to  $\delta_{cr}/t_s = l/t_s$  is assumed (fig. 6), the critical crack length depends directly upon the reinforcement ratio, that is, the ratio of cross-sectional area in the rings  $A_{R_{red}}$  to the associated skin area  $lt_s$ . Thus, as might be expected, the critical crack length at a given hoop stress is longer for a large value of  $A_{R_{red}}/lt_s$  than for a small value of the reinforcement ratio.

Because this analysis is oversimplified, the plotted straight-line relationships of figure 6 for critical crack length should perhaps be regarded as upper limit or maximum values which can seldom practicably be achieved, and, accordingly, these curves do not provide a suitable criterion from which it can be determined whether a cylinder is prone to explosive failure. Such factors as bulging of the skin between rings and local stress concentrations probably tend to reduce the length of crack that can be tolerated below that given by the straight-line relationship of figure 6 (though not below that corresponding to the unstiffened cylinder). A rigorous analysis of the stress distribution along the cracked skin, or adequate test data, is required to establish a critical-crack-length criterion which is surely not unconservative.

A more conservative criterion is given by the end points of figure 6, that is, for the ratio of critical crack length to ring spacing of one. These end points represent rings of cross section heavy enough to carry the entire hoop-tension load by themselves with the skin cracked over the full bay length.

Figure 6.- Simplified relationship between hoop tension and critical crack length for 2024-T3 aluminum-alloy stiffened cylinders.

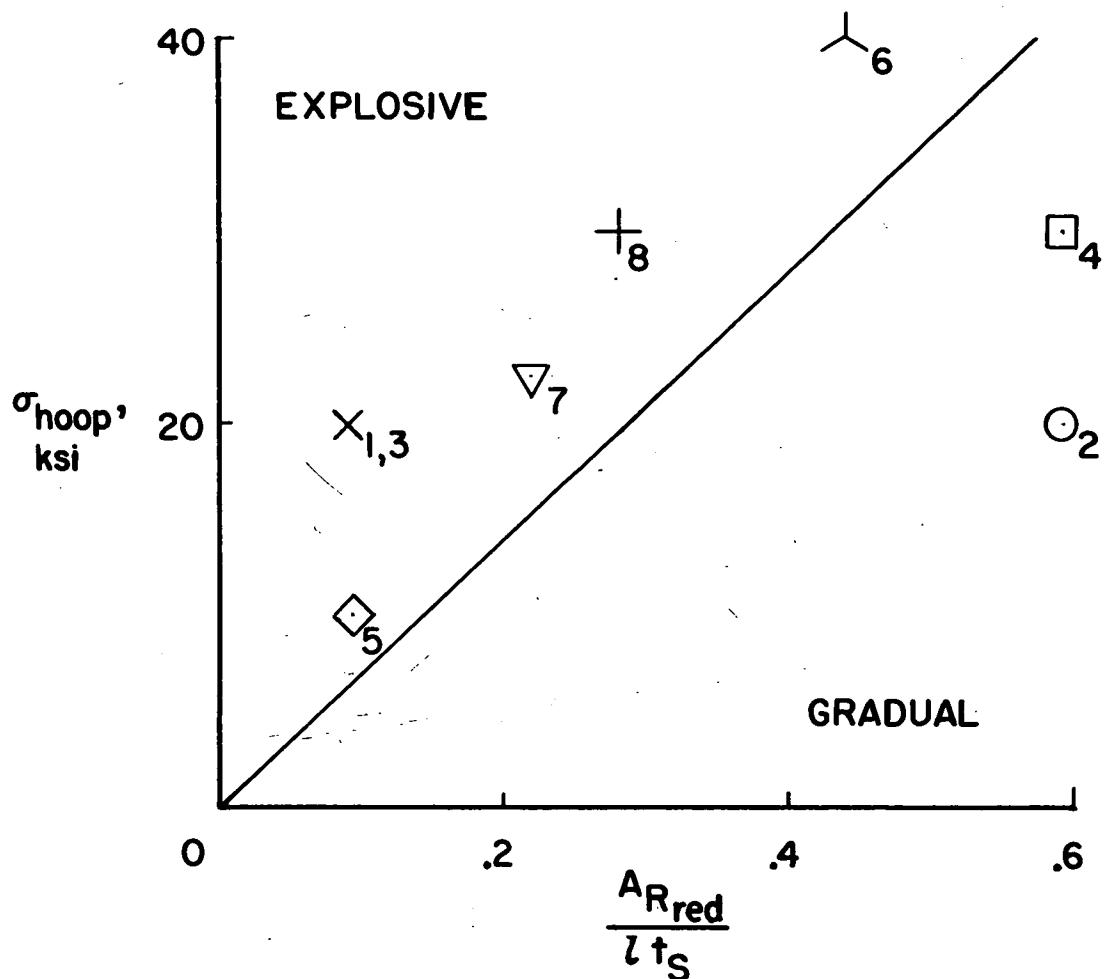
A plot of these end points (the straight line in fig. 7) as given by equation (2) may perhaps be worth investigation as a gross kind of criterion for a boundary (which should tend to be conservative particularly at low stresses) between regions of slow and explosive crack propagation in the skin of stiffened pressurized cylinders. The present test data, plotted in figure 7, substantiate to some extent the conservatism of this criterion. The open points  $\times$ ,  $\swarrow$ , and  $+$ , representative of the explosive failures, fall above the line which represents the ring area required at any hoop tension to carry the entire hoop-tension load with the skin cracked along the entire bay length. The closed points

$\circ$ ,  $\square$ ,  $\diamond$ , and  $\nabla$ , representative of the specimens in which the crack grew gradually, fall below or not far above the straight line. Thus, the data tend to confirm that for the type of construction tested this boundary is somewhat conservative.

The type of boundary given in figure 7 is probably too conservative at the low stress levels which correspond to the stresses required for explosion of an unstiffened cylinder. Data to establish quantitatively, for low stresses and large width-thickness ratios, curves like that of figure 5 would be of assistance in the evaluation of the type of failure to be expected in this low stress region.

Figure 7.- Regions of explosive (open points) and gradual (closed points) crack growth as measured by reinforcement-ratio criterion for 2024-T3 aluminum-alloy pressurized-stiffened-cylinder specimens 1 to 8.
